# **COMPREHENSIVE MOTOR VEHICLE SERVICES & CONSULTING Motor Vehicle Forensic Analysis Report**

**People of the State of New York v.**  
**Nauman Hussain**

CMVSC-18-VA-253

**REFERENCED INVOLVED SUBJECT VEHICLE:** 2001 Ford Excursion Stretch Limousine,  
VIN 1FMNU40S51EB10299

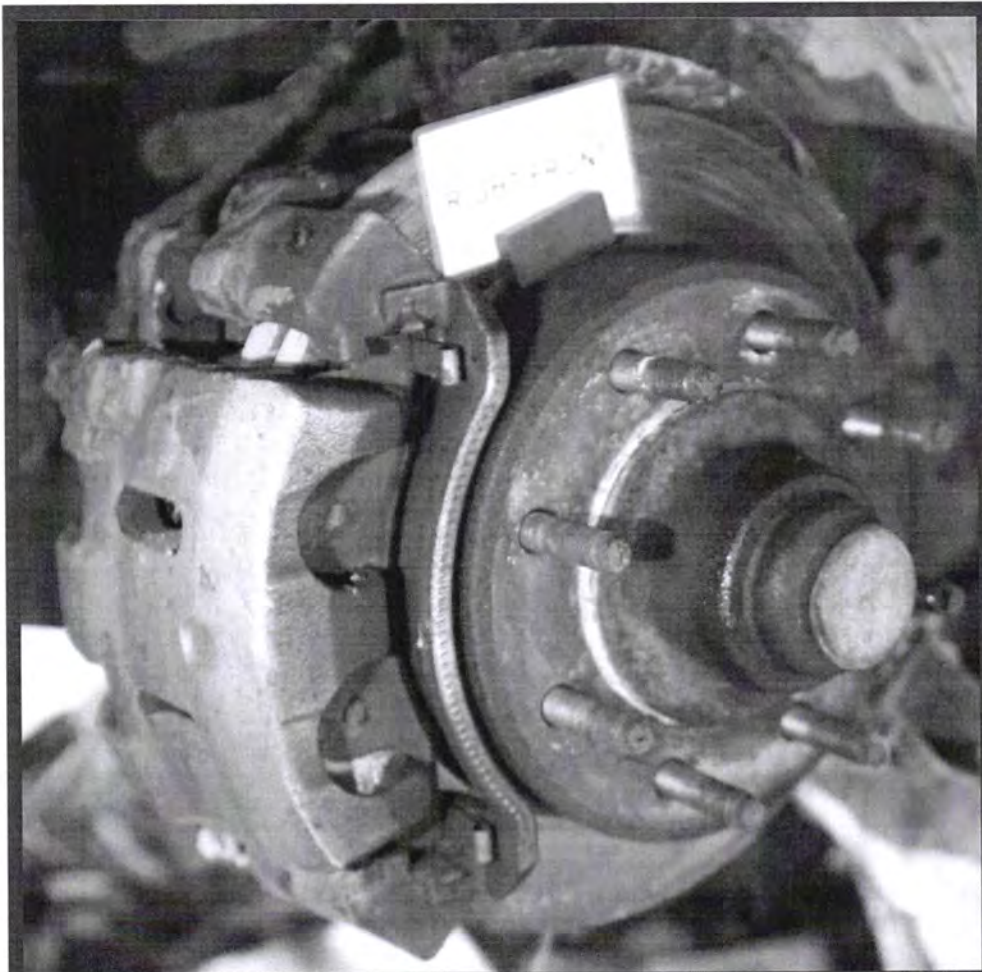
**Image No.35.** This photograph depicts the right front disc brake components of the 2001 Ford Excursion stretch limousine. The extreme thermal effects were prevalent, inclusive of the pungent odor of burnt materials/components which was overpowering at the time of examination.

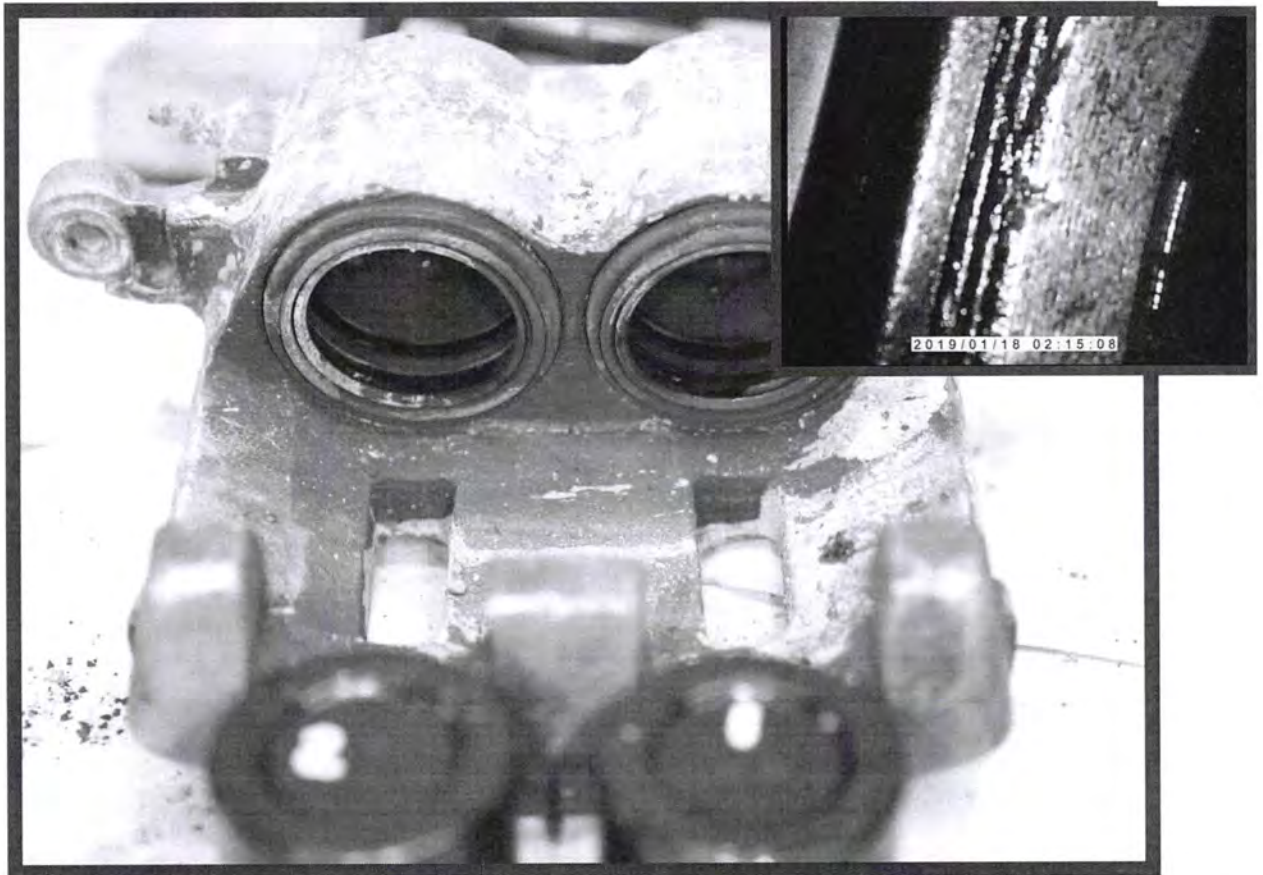
**Image No.36.** This photograph depicts the right front disc brake caliper of the 2001 Ford Excursion stretch limousine during the period of individual component analysis, following removal of the caliper pistons to allow for examination of the pistons, caliper body bores, and piston seals. As with all front braking system components, the effects of severe thermal distress were clearly evident -- including the intense pungent odor of burnt materials/components.

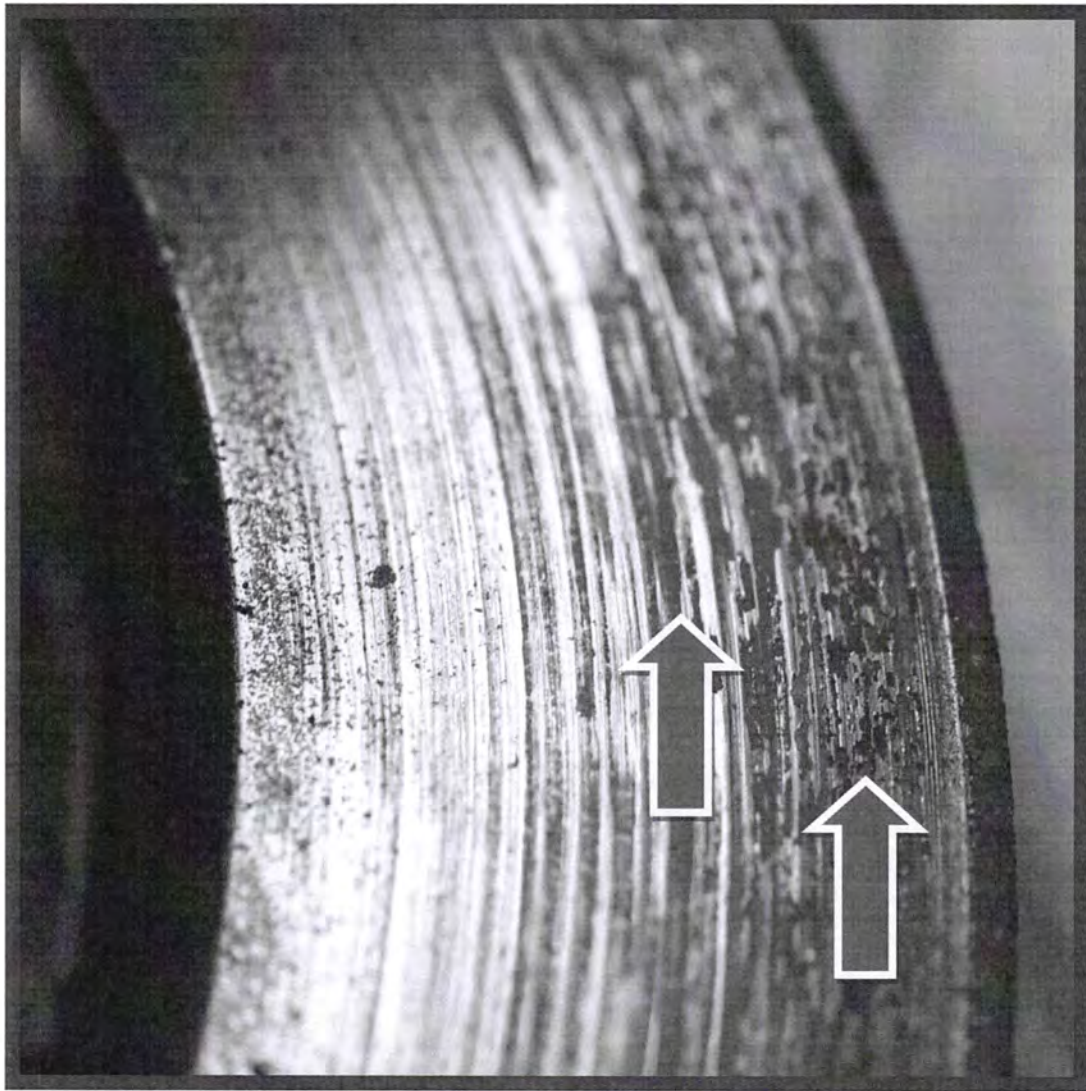
**Image No.37.** This photograph depicts the outer swept area of the right front disc brake rotor of the 2001 Ford Excursion stretch limousine during the period of individual component analysis. As with all front braking system components, the effects of severe thermal distress were clearly evident, including embedded material consistent with thermal deterioration of disc brake pad friction material during braking (Red Arrows).

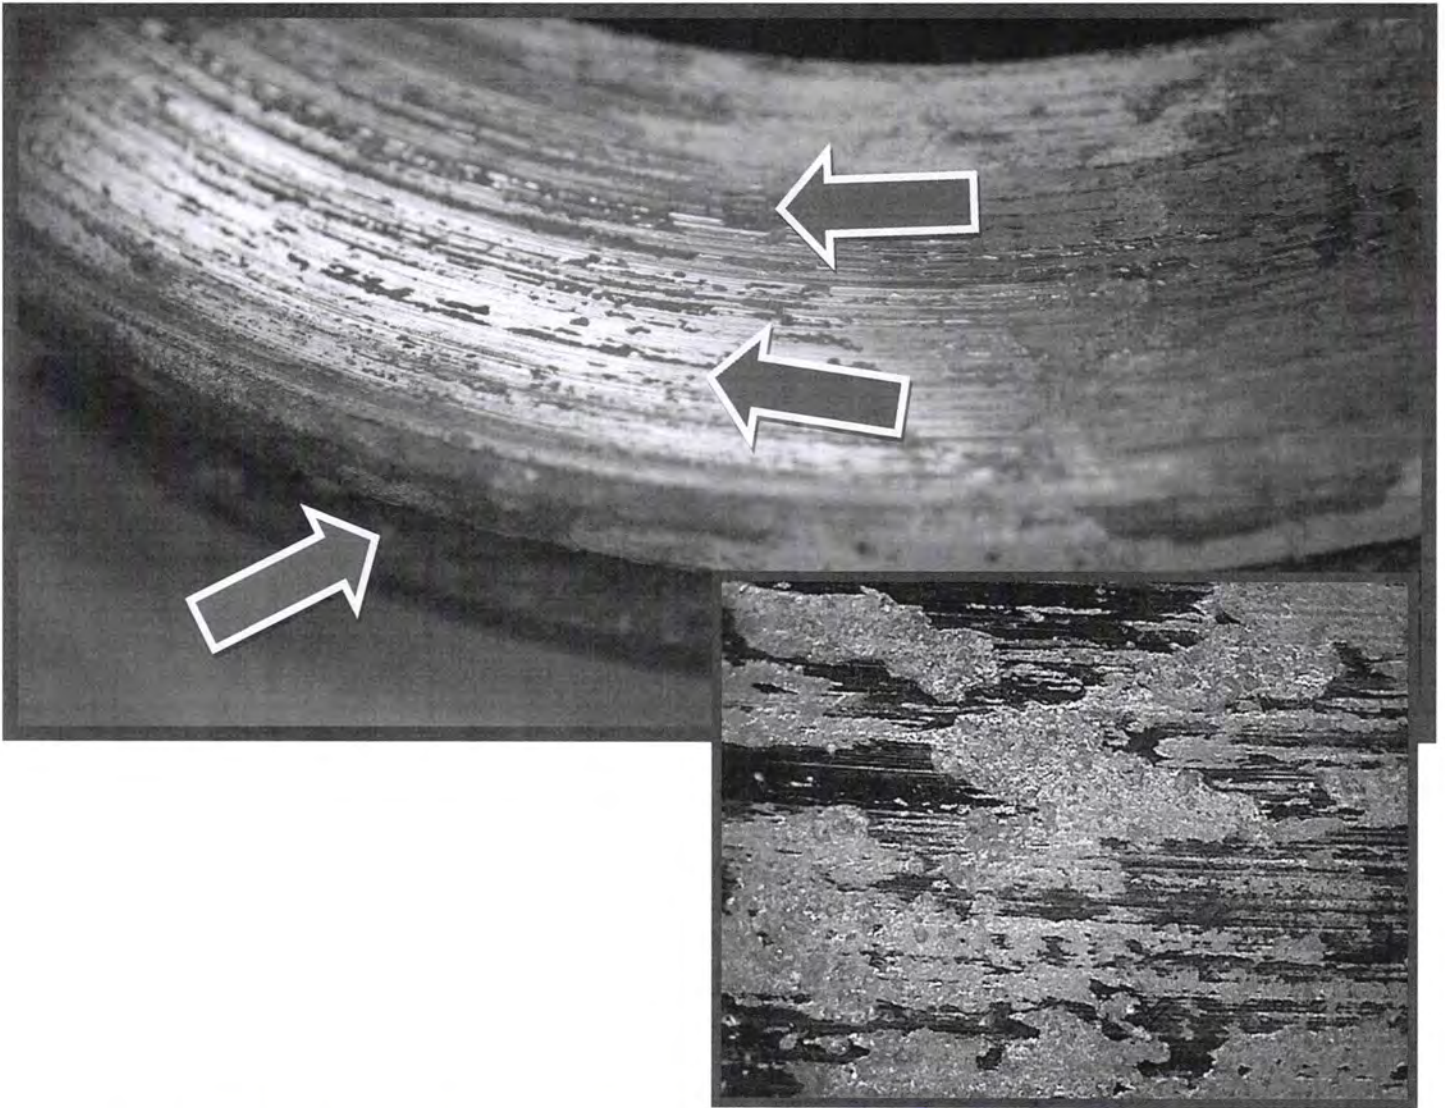
**Image No.38.** This photograph, with Digital Microscope image insert, depicts the inner swept area of the right front disc brake rotor of the 2001 Ford Excursion stretch limousine during the period of individual component analysis. The effects of severe thermal distress from braking were clearly evident - the Red Arrows denote areas of embedded material consistent. The significant corrosion present at the vent area vanes resulted in a reduction in thermal energy transfer (Blue Arrow).

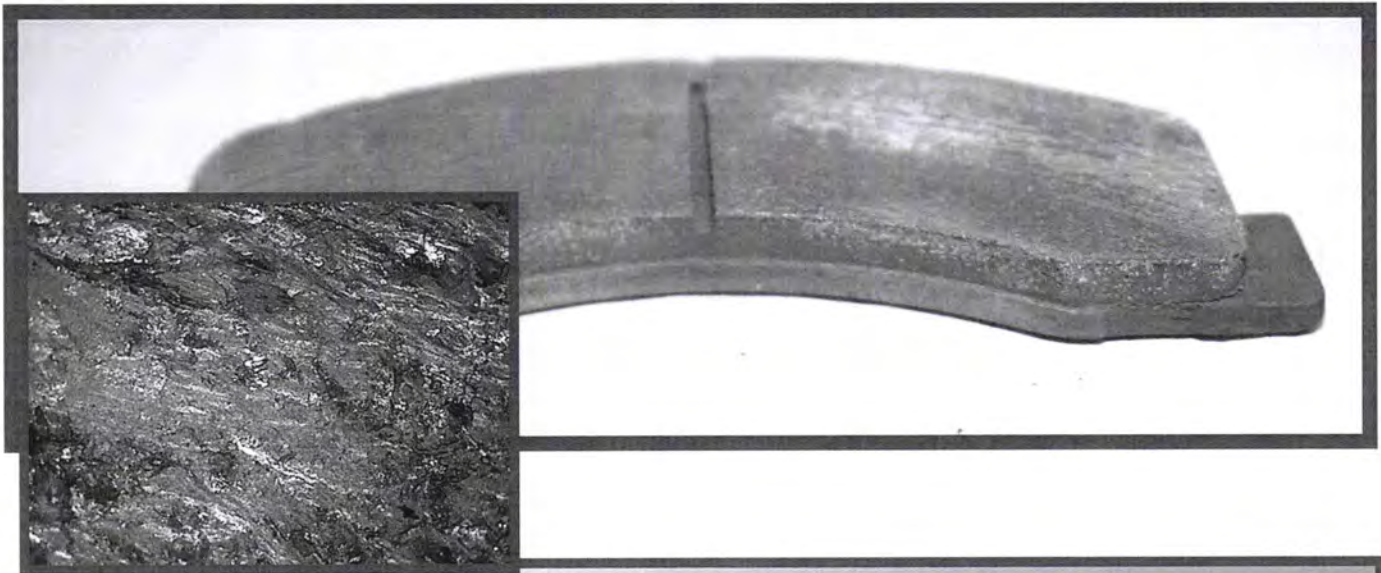
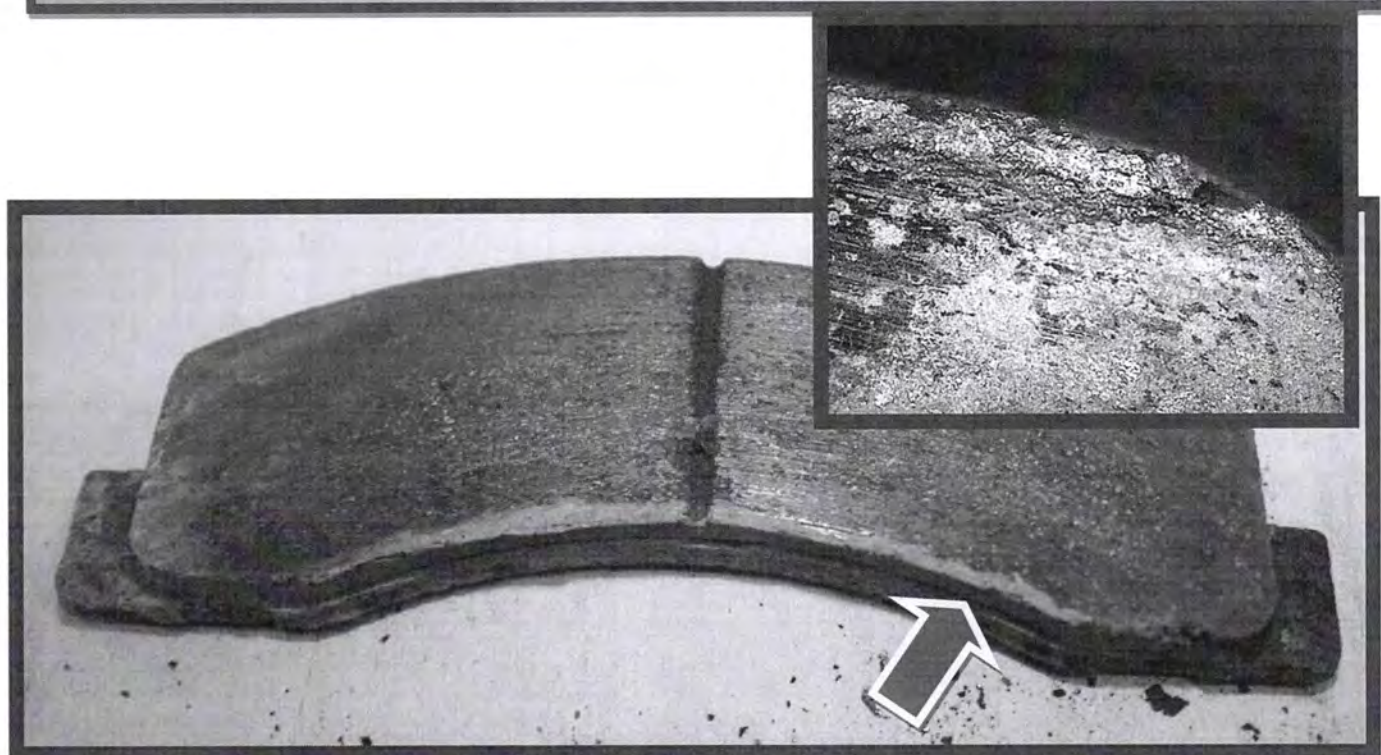
**Images No.39a & 39b.** These photographs, with Digital Microscope image inserts, depict the outer disc brake pad friction material (above photographs) and the inner disc brake pad friction material (below photographs) of the right front disc brake pads of the 2001 Ford Excursion stretch limousine during the period of individual component analysis. As with all front braking system components, the effects of severe thermal distress were clearly evident, including delamination and glazing as denoted by the insert photographs. The Red Arrow depicts separation of the bonded friction material from the steel foundation of the disc brake pad, consistent with extreme temperatures from braking.

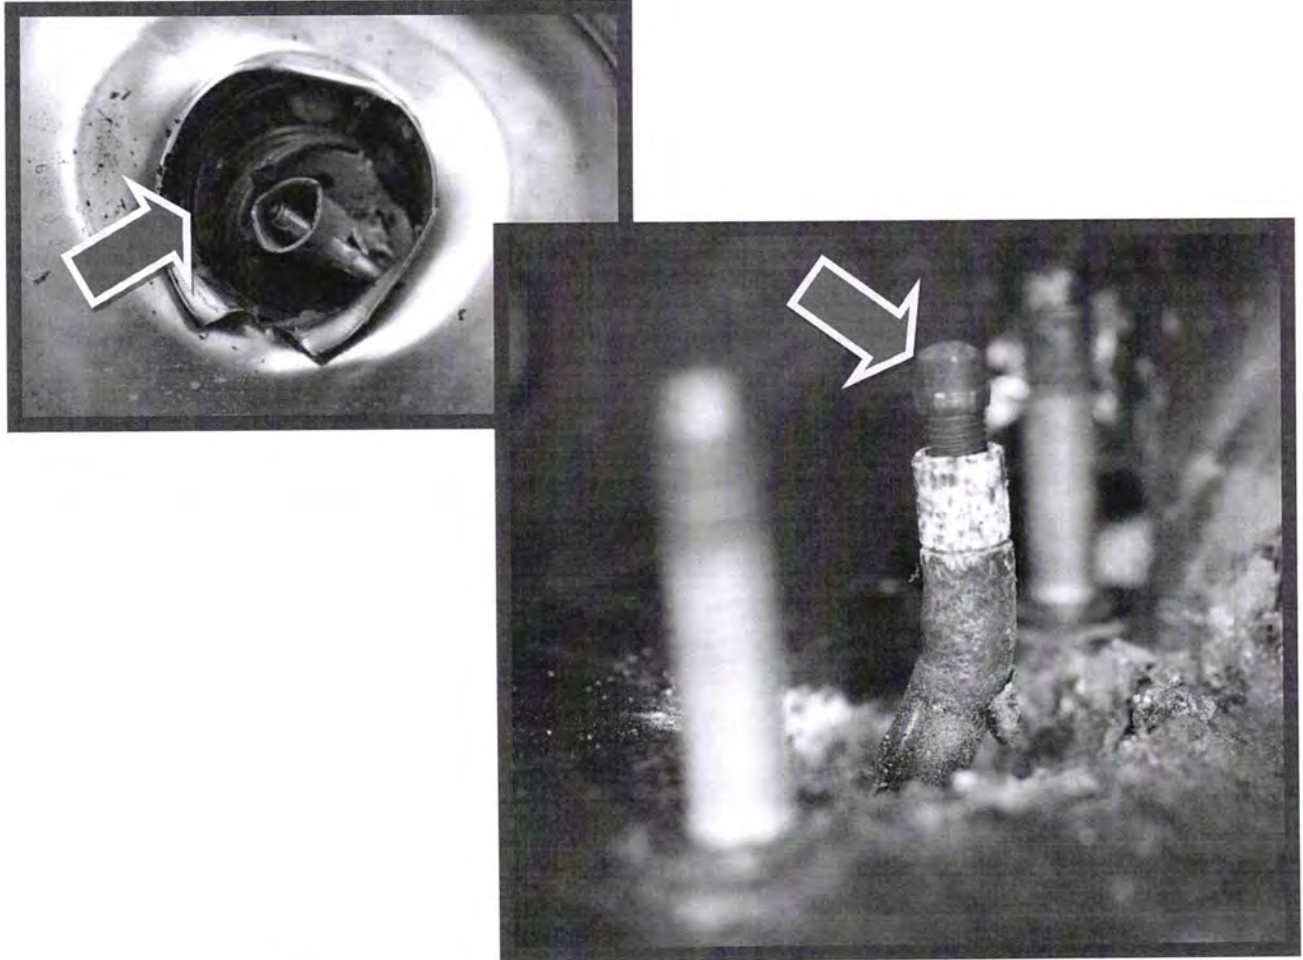
**Image No.41a & 41b.** These photographs depict the brake master cylinder push rod (lower photograph) and the power brake vacuum booster of the 2001 Ford Excursion stretch limousine during the period of individual component analysis. The state of compression of the internal power brake vacuum booster (Red Arrow), and the extended position of the brake master cylinder push rod of the power brake vacuum booster (Blue Arrow), are consistent with that of brake pedal depression by the vehicle operator at the time of impact, which seized the components in position.

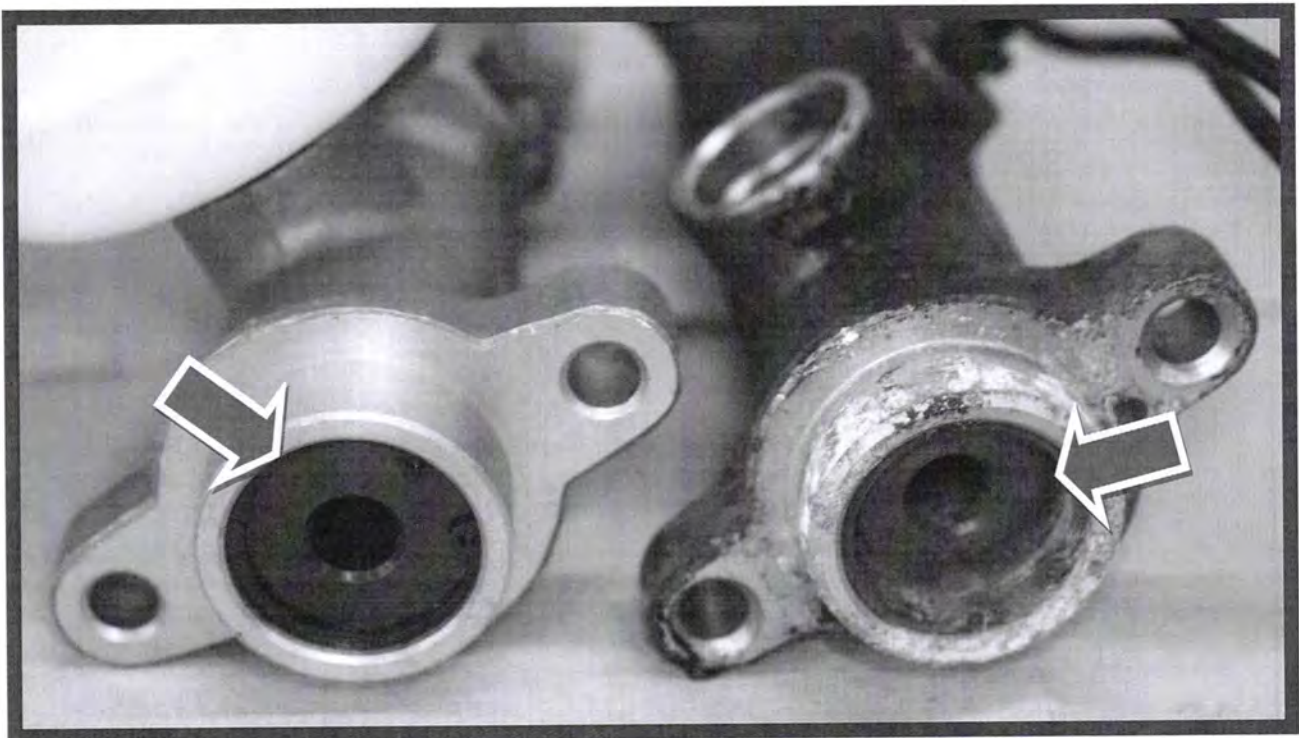
**Image No.42.** This photograph depicts the brake master cylinder of the 2001 Ford Excursion stretch limousine during the period of individual component analysis (photo right), compared to a new replacement brake master cylinder of the same manufacturer and part number (photo left). The state of seized compression of the primary piston of the involved vehicle brake master cylinder is denoted by the Red Arrow, while the normal spring extended primary piston state is denoted by the Blue Arrow. This post crash condition is further consistent with that of brake pedal depression by the vehicle operator at the time of impact.

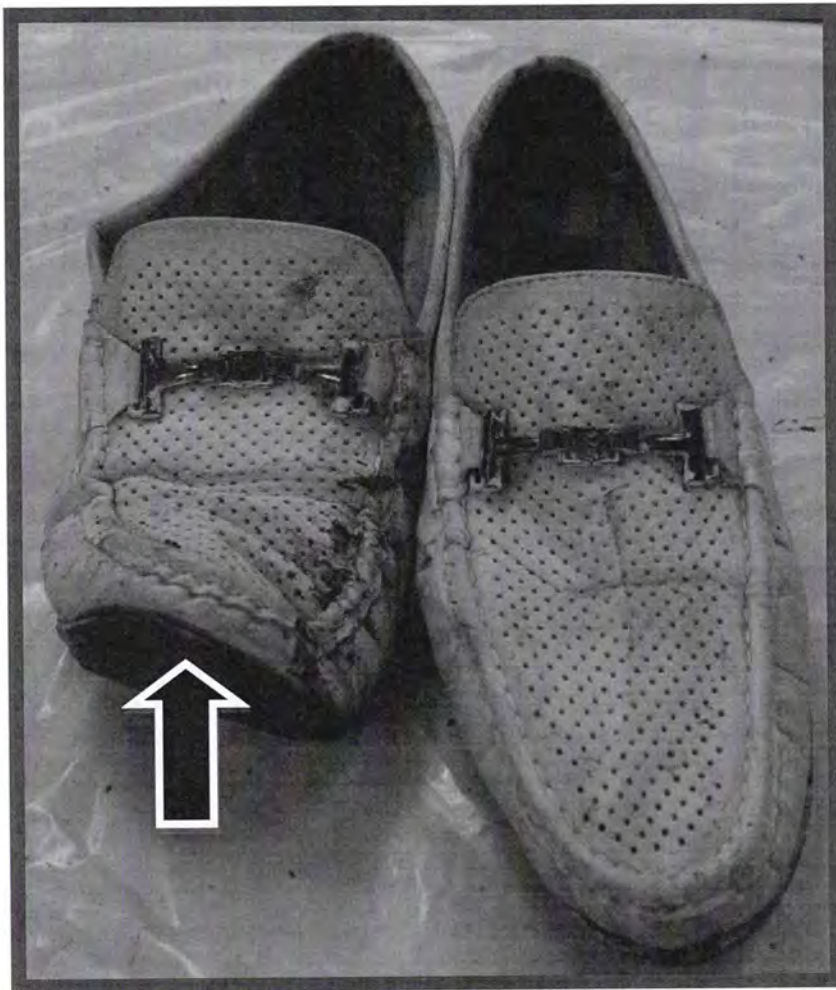
**Image No.43.** This photograph depicts the shoes worn by the operator of the 2001 Ford Excursion stretch limousine at the time of the crash on October 6, 2018 in Schoharie, New York. Note that one of the shoes exhibits remarkable deformation at the forward section (Black Arrow), consistent with that section of the foot providing brake pedal depression at impact.

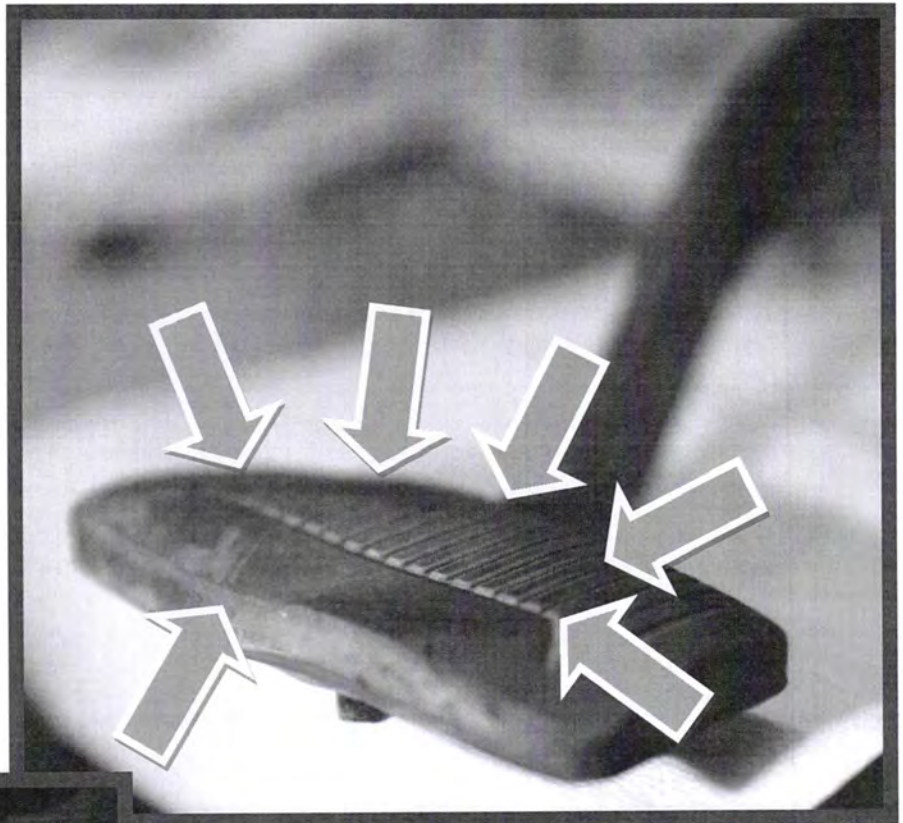
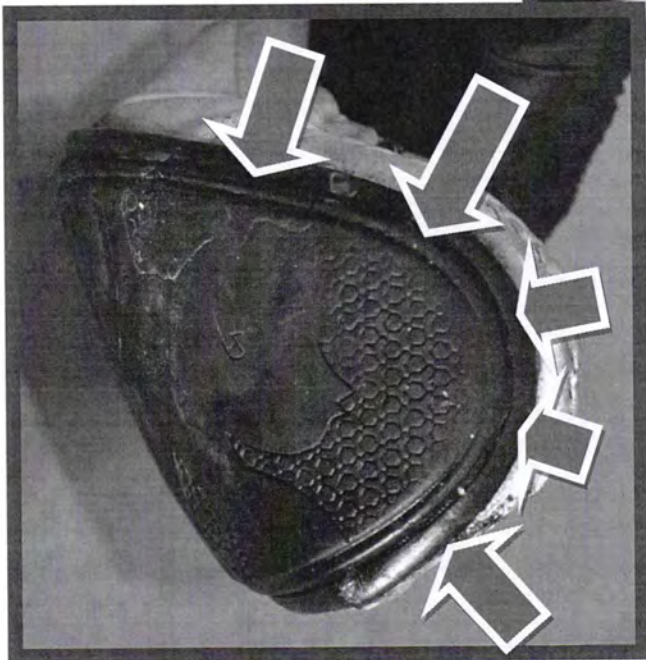
**Image No.44a & 44b.** These photographs depict the rubber composition brake pedal pad of the 2001 Ford Excursion stretch limousine during the period of individual component analysis (above photograph; and the shoe worn by the operator of the vehicle at the time of impact on October 6, 2018 in Schoharie, New York (left photograph). Note the semi-circular depression imprint of the brake pedal pad (Orange Arrows), which is consistent with the shape of the deformed shoe worn by the operator of the vehicle.
